Transactions of
Perthshire Society
of Natural Science

VOLUME XIII
(1979-80)

The Design and Construction of Friarton Bridge

H G Binnie

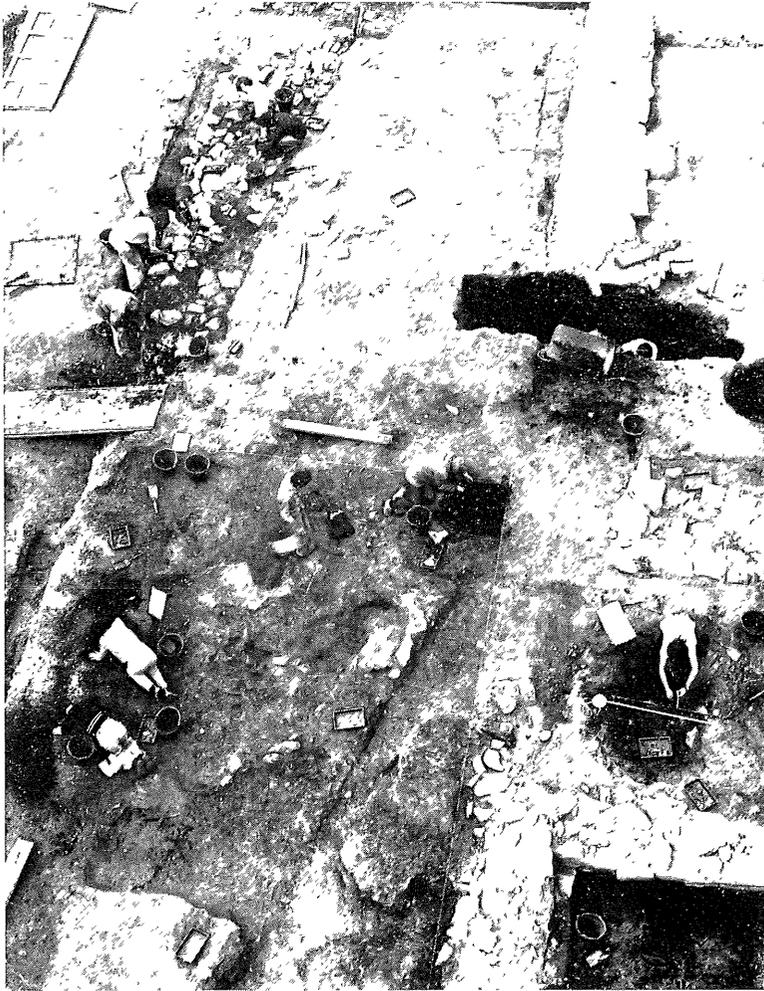
Work on the site during the second season. The paving in the top left hand corner is the level of Bunch's Vennel, later Parliament Close, dating from c1300.
